# Manhole Inspection Summary

Manhole # S35U\_\_050MH

Insp Date: **2/13/08 2:09 PM**

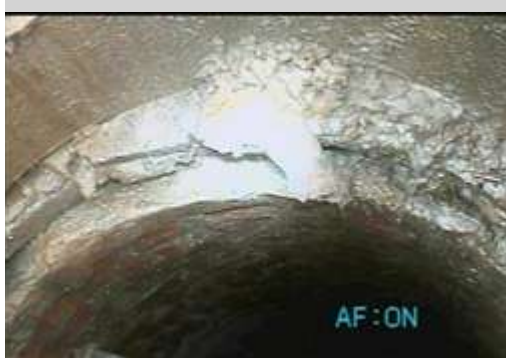
Defect 1

Offset: **1** (in.)

Condition: ☐ Sound ☒ **Cracked** ☐ Root Intrusion ☐ Loose Brick ☒ **Deteriorated**

frame offset, cracked deteriorated chimney

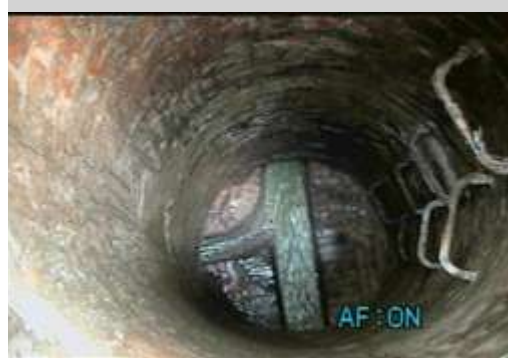
Defect 2

Count: **8** Missing: **0** ☒ **Corroded**

corroded steps

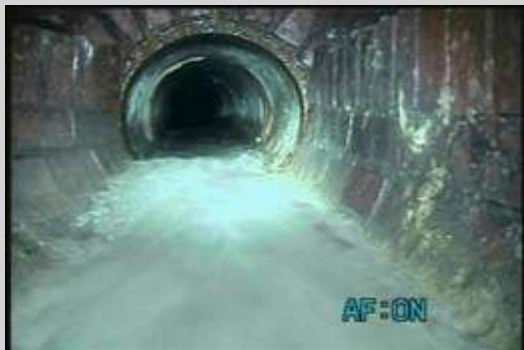
12 O'Clock Outflow

15 in. Circular Gravity Sewer  
Pipe Out @ 12 O'Clock

Invert Depth: **13.90** (ft.) Flow Characteristics: **Fast**

Infiltration: **None** Pipe Seal Cond: **Unknown**

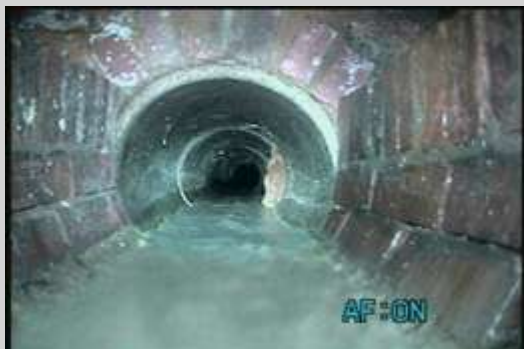
6 O'Clock Inflow

12 in. Circular Gravity Sewer  
Pipe In @ 6 O'Clock

Invert Depth: **13.80** (ft.) Flow Characteristics: **Fast**

Infiltration: **None** Pipe Seal Cond: **Unknown**

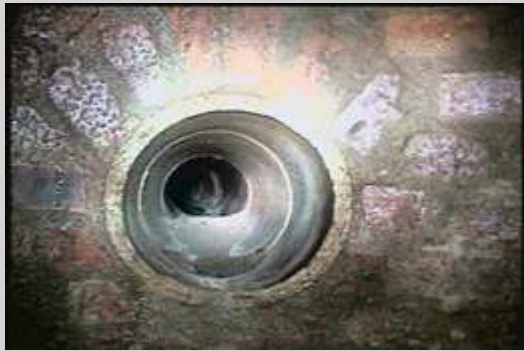
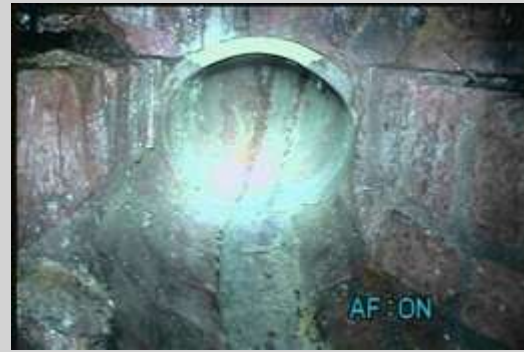
9 O'Clock Inflow

8 in. Circular Gravity Sewer

Pipe In @ 9 O'Clock

Drop In @ 9 O'Clock

Drop: **Inside** **Direct**

Drop Condition: **Open**
